**AUTUMN 2012 ENA
SHE MANAGERS
REVIEW OF PAST ASSET
RELATED INCIDENTS**

SHE REVIEW – AUTUMN 2012

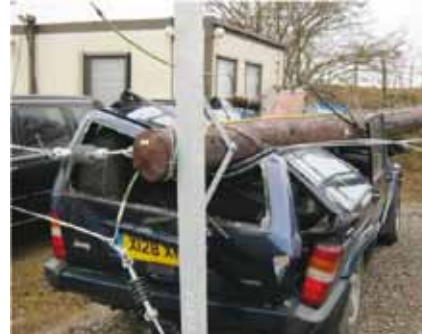
POLE FALLS INTO CAR PARK

In one incident an 11kV terminal pole with a pole transformer mounted on it fell into a car park damaging eight vehicles and writing one of them off.

The direct cause of the collapse was found to be that the pole had not been installed to the correct depth.

Underlying and contributory causes included:

- > Inadequate assessment of the site and soil conditions.
- > Failure to install to correct depth, and use a baulk.
- > Poor supervision, quality control and auditing of the installation process.

- > It is important that anyone involved in the erection of poles is competent to assess site conditions and understands the importance of good installation.
- > Always install poles to the correct depth.
- > Robust supervision and quality control of the process is needed.

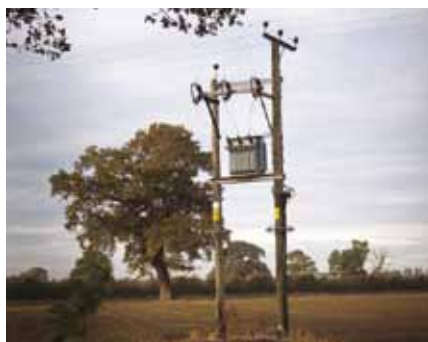
POLE FALLS PARTIALLY AS CONDUCTORS AND PLANT ARE TAKEN DOWN

In another incident a team was dismantling an OHL on sloping ground and removed the conductors on the uphill side of a pole mounted transformer. As the transformer was being removed from the pole, the pole started to fall down the slope until it was restrained by the stay wire which caught in a tree. Two linesmen were attached to the pole and one was slightly injured.

On investigation it was found that there was a void in the ground around the base of the pole, which was not visible prior to the work.

- > The pole was not firmly secured in the ground, either due to poor installation or subsequent erosion.
- > The on-site risk assessment and subsequent method adopted did not identify this possible risk.

- > If possible, complete other work on a pole before removing conductors.
- > Inspect poles carefully before climbing them.
- > If necessary, provide temporary support for the pole.
- > Always ensure poles are installed correctly, and that backfill is properly consolidated and rammed.

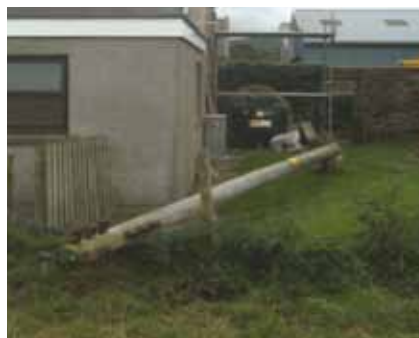
DECAYED POLES

There have been a number of incidents where linesmen have climbed decayed poles which have then fallen while the linesmen were on the pole. Some of these have resulted in serious injuries or fatalities, both to linesmen on the poles and to others who have been hit by the falling poles.

- > Failure to test poles properly before climbing them.
- > Climbing poles marked as defective.
- > Not changing defective poles.

- > Asset Management procedures need to ensure that decayed poles are effectively identified, recorded and removed in a timely manner.
- > Always check poles first for any notices or signs indicating they have been marked as defective. Make sure you understand the system your company uses for this.
- > Test every pole first using the method approved by your company. Make sure you understand how to do this.
- > Do not climb or work upon a suspect pole unless it is supported in an approved manner.
- > Always use the hierarchy of access methods for working at height.

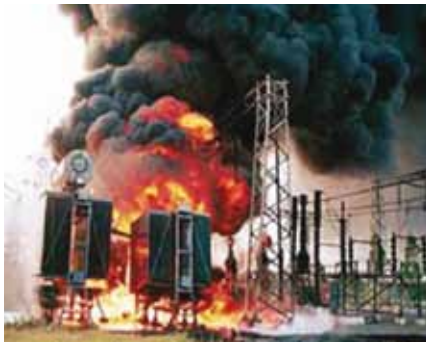
TAP CHANGER FATALITY

A fatal incident occurred when an engineer tried to manually operate a high voltage tap changer and the unit exploded, killing the engineer.

The direct cause of the incident was the failure of the mechanism in the tap changer leading to an electrical fault which caused the oil in the unit to ignite and explode.

- > A failure to carry out a modification to the tap changer which had been recommended some years before.
- > The failure to understand the significance of repeated tap changer alarms and malfunctions.

- > Alarms and defects on plant should be dealt with by staff who are trained and experienced in the maintenance of that type of plant.
- > A robust asset management system is needed to ensure that recommended modifications are recorded, scheduled and carried out.
- > Repeated alarms should be interpreted as an indication that there may be a more serious underlying problem which needs to be investigated.

- > Manual live operation of tap changers should be reviewed and risk assessed, with appropriate controls applied.
- > Where evidence exists that the internal mechanisms of either the diverter or selector are damaged, the unit should not be operated live.
- > Ensure that staff dealing with alarms and defects on equipment have the knowledge, skills and competency to deal with that equipment.

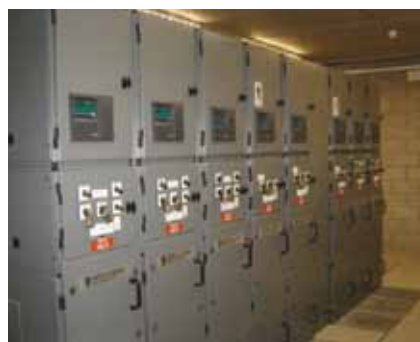
33KV INCIDENT

In a similar incident involving 33kV switchgear, a test lead was left on cable terminations and subsequently the covers were replaced with the test lead still connected, resulting in an explosion and extensive damage when the circuit was re-energised. No one was injured in this case.

- > The engineer made contact with live test plugs which were left inserted in the busbar spouts at the time they were re-energised.
- > The test lead was left inside the gear.

- > Failure to remove the test prods and test leads.
- > Failure to check and confirm that the test plugs and test leads had been removed before the Sanctions for Test were cancelled. ¹

- > Wherever possible, re-energise from the point at which testing was done, and don't remove panels to enable testing unless there is no other option.
- > Always check that test plugs, tools and any other items have been removed from busbar and circuit spouts that were under test and that the spouts have been locked shut before the Sanction for Test is cancelled.
- > It is important to remain focussed throughout all switching and HV testing activities. Avoid distractions, exclude those not involved, and use a checklist if necessary to help correct restoration.
- > Never touch or try to remove test plugs or connections from busbar or circuit spouts if the circuit concerned is not subject to a safety document which allows you to do so.

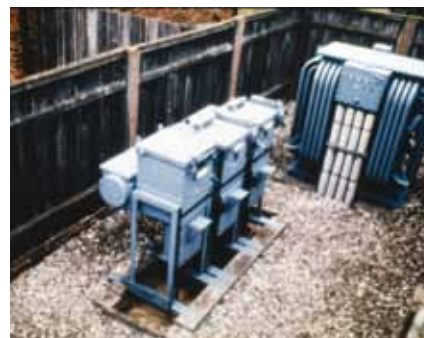
SIGNS OF DAMAGE, VANDALISM AND TRESPASS

Two small boys trespassed into a substation and were killed when 11kV switchgear faulted while they were playing in the substation.

The fault occurred on a busbar joint chamber which joined the busbars of two items of switchgear in the substation.

The investigation concluded that the equipment had probably been damaged by a previous event which had left the cover fractured, allowing the ingress of moisture.

- > Reporting damage to equipment before it faults can save lives.
- > Once defects or damage are reported, they must be appropriately prioritised and rectified in a reasonable timescale.
- > Always check for and report any signs of damage, trespass and vandalism.
- > If a predominantly underground circuit trips but no fault is found, give consideration to further inspection of sites on the circuit.
- > Use the ENA booklet on substation security or your company's own guidance on substation security.

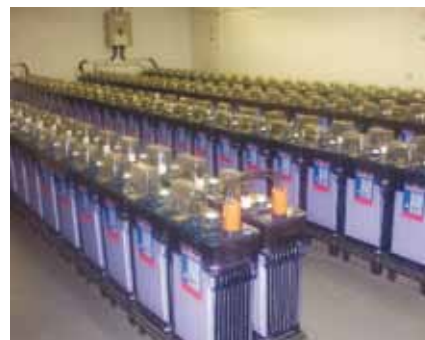
COMPLETE BATTERY STOLEN

All the cells from a number of primary substation batteries were stolen, but this was not noticed immediately because the battery charger was connected across the battery terminals.

- > Theft of batteries.
- > Inadequate checking and monitoring procedures and techniques.

- > We all need to be vigilant for signs of intrusion and theft.
- > Effective control of access to substations and keys must be ensured.
- > The design and maintenance processes should ensure that the routine inspection and testing of batteries reliably indicates cell and battery condition.
- > A robust regime of battery testing and monitoring should be implemented.

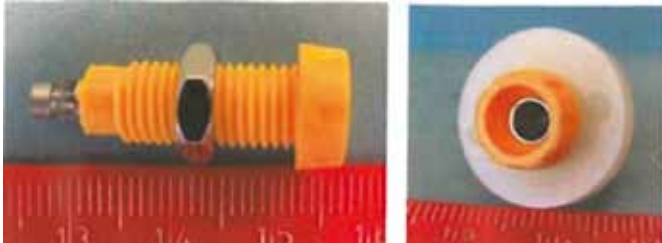
FAILURES OF TEST CONNECTIONS ON LV BOARDS

An engineer was using un-fused test leads to measure voltage by plugging into the 4mm un-fused test sockets on an LV Board.

A flashover occurred and the engineer received burns to his hands. It is believed that the insulated body of the test socket failed and the conducting part of the broken socket made contact with the earthed metal of the LV Board.

Other incidents had also involved test leads with terminations that were not 4mm plugs being forced into the sockets.

- > Poor design.
- > Use of wrong plugs.
- > Lack of care when using sockets.

- > Always use test leads with fuses when taking measurements on live equipment.
- > Known defects should be effectively followed up promptly to avoid similar incidents on the same type of equipment or plant.
- > Consider reporting any defects to the ENA NEDERs scheme through your company contact.
- > Consider banning the use of components that have a generic fault which can lead to dangerous incidents.
