Health and safety briefing

11 October 2023

Reinforced Autoclaved Aerated Concrete (RAAC) FAQ

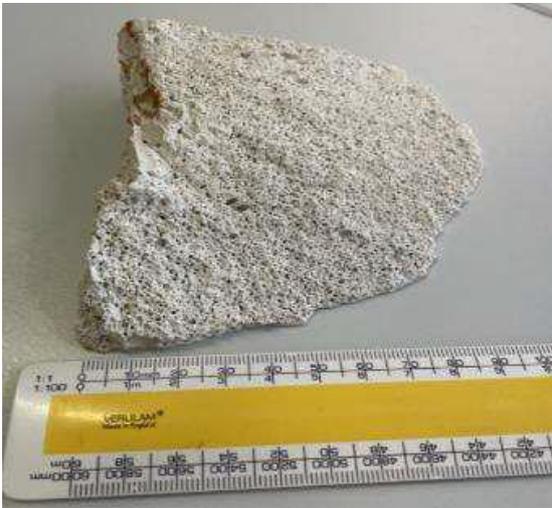
Reinforced Autoclaved Aerated Concrete (RAAC) is a form of concrete with a bubby texture that was commonly used in construction between the 1950s and 1990s. Its aerated texture means it is much lighter than typical reinforced concrete, but not as strong. It was predominantly used in a wide range of buildings as precast panels or planks in roofs (generally flat roofs, although sometimes pitched) and occasionally in floors and walls.
